Report No. NAWCADWAR-93015-60

AIRCRAFT CARRIER EXPOSURE TESTS OF CAST MAGNESIUM ALLOYS

1 MARCH 1993

FINAL REPORT

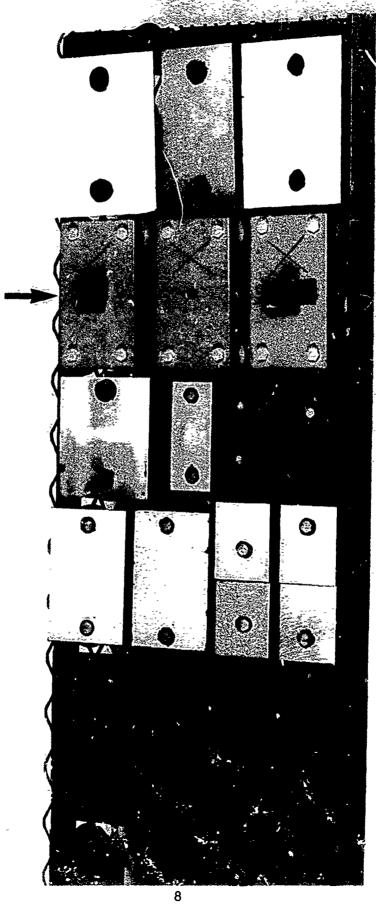
Figure 2. Magnesium Test Blocks Prior To Shipboard Exposure.

appearance of the magnesium alloy test specimens prior to shipboard exposure is shown in Figure 1 (second from the right) and Figure 2 (second from the left). Note the aluminum blocks attached to the top and bottom specimens. From top to bottom, the specimens are DF1471-3, DF1440-1, DF1312-3 (Figure 1) and DF1312-4, DF1440-2, DF1471-4 (Figure 2). Specimens 1312 are WE-43 magnesium alloy and specimens 1471 and 1440 are QE-22.
